CFMEU ALERT

FORMWORK SHUTTER & LIFTING POINTS

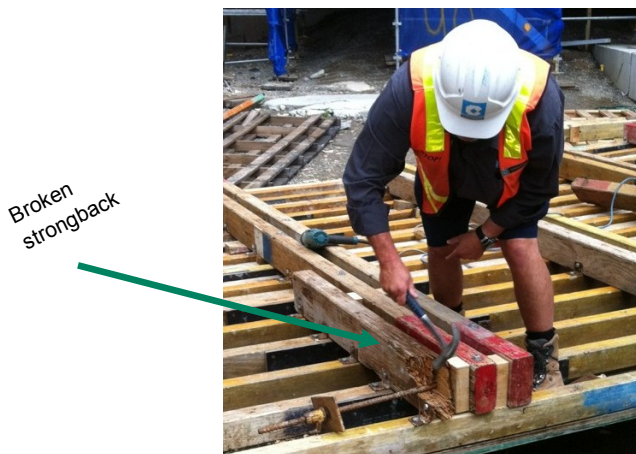
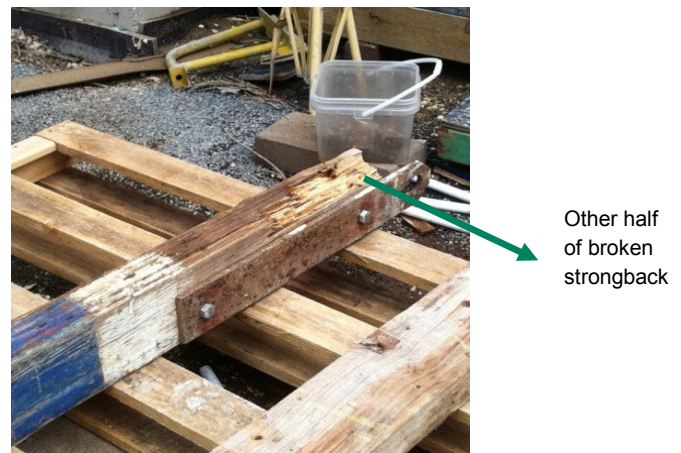
It would appear the shutter was being extended in height by at least the width of a sheet of form ply, and was going to be used to form a higher wall. Extra strongbacks that were not part of the original shutter design had been fitted and were some 1.2-1.5 metres higher. It is believed that the shutter was in the process of being lifted up by a crane to turn it over to fit the extra soldiers and form ply needed for the extended height, when the failure happened.

The extended strongbacks appear to have failed under the extra load exerted by the lateral force of the attached lifting chains causing the shutter to tragically fall on the worker.

Ensure that Engineers approval is received and verified on the design and construction of all Formwork shutters.

All lifting points are be part of that approval, and a record of maintenance and use must be available for inspection at any time.

Any modifications to the original engineer approved design of any Formwork shutter must be approved and verified again by an engineer before use.
