### **BACKGROUND:**

A tree lopper has been fatally injured while working from a cherry picker. Two workers were in the process of trimming a tree adjacent to a car garage at a height of approximately 40m when, it would appear, that a section of the boom has failed resulting in them being thrown from the basket onto the roof of the garage. The other worker in the basket has survived the fall.

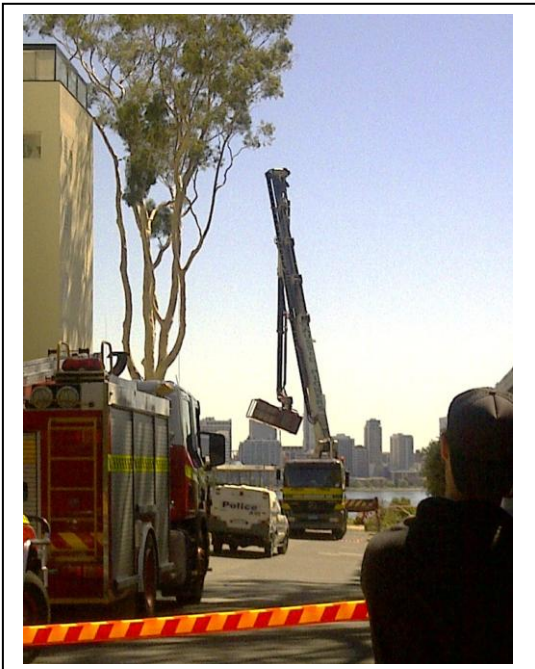
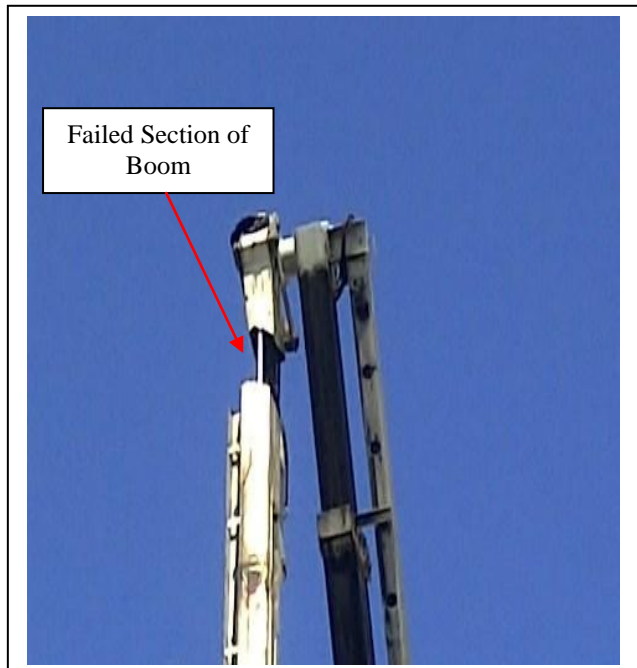
The apparent failure has taken place approximately mid way up the boom, the basket has then swung down in a pendulum action, throwing the workers out of the basket.

It was reported that they were both wearing a harness and connected to the basket at the time of the incident but there was insufficient clearance between the basket and the roof for the safety lanyards, which are attached to the harness, to take effect and arrest the fall before coming in contact with the roof.

- Maintain and service all machinery in accordance with the manufacturers recommendations.
- Always conduct pre start checks prior to use and complete log books.
- All employers should ensure that any employees using any type of machinery or equipment have undergone the required training.
