URGENT SAFETY ALERT

SCAFFOLD STAIR FAILURE

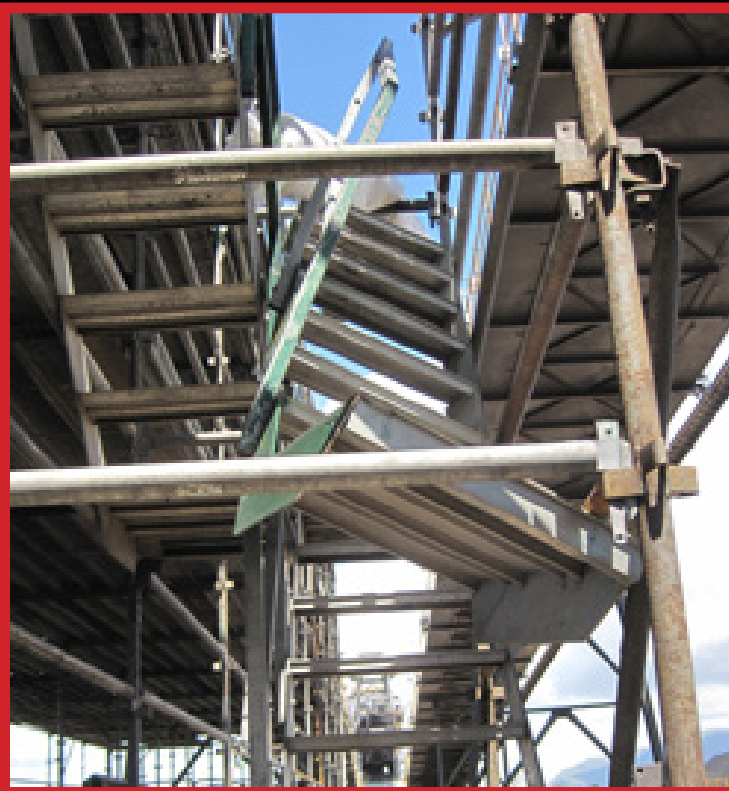
Please undertake a site safety audit on ALL Scaffold Stair tread systems. A number of incidents have occurred in Queensland where modular scaffolding stair units have dropped or stair treads have failed.

There are a number of factors that contribute to the risk of stair modules falling off the supporting transoms, including the following:

- Inadequate support provided by the scaffolding transoms underneath both ends of the stair module, for the width of the module. In other words, the gap between the end of the module and the vertical face of the transom is too big (see Photograph 4) - often caused by the stair module being too short or the scaffolding not being square.
- Insufficient welds being located at critical points of the stair modules - often due to 'tack' welds being used instead of continuous or stitch welds (see Photograph 3).
- Stair modules, including welds, being damaged or cracked - particularly during assembly, dismantling and transport.
- The supporting transoms underneath the stair module being able to twist or rotate - possibly due to loose connections.

Any faulty/inadequate stair tread systems identified through this process should be removed from service immediately.
